Manhole Inspection Summary

Manhole # S35GG_007MH

Location Address: **208 HUNTER ST**

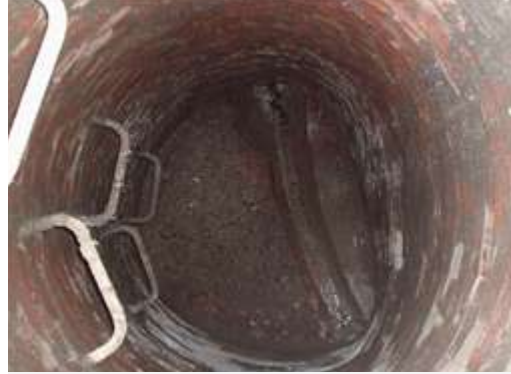
Top View

Infiltration: ☐ None ☒ **Joint** ☐ Cracks ☐ Mortar ☐ Roots ☒ **Wall**

Adjustment and Barrel infiltration. Bench debris.

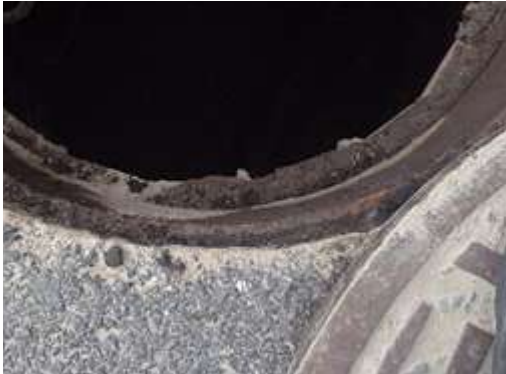
Defect

Frame Offset: **1** (in.) Condition: ☒ Sound ☐ Cracked ☐ Leaks

Frame offset.

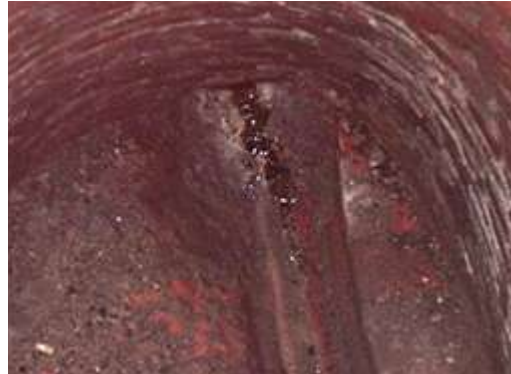
Defect

Condition: ☐ Sound ☐ Cracked ☐ Root Intrusion ☒ **Deteriorated** ☐ Leaks ☐ Debris

Bench and Channel deterioration.

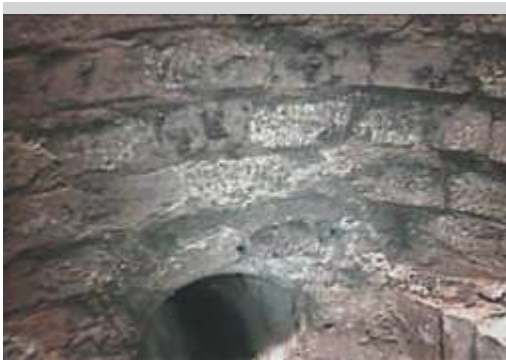
Defect

Condition: ☐ Sound ☐ Cracked ☐ Root Intrusion ☐ Loose Brick ☒ **Deteriorated**

Infiltration: ☐ None ☐ Joint ☐ Cracks ☒ **Mortar** ☐ Roots ☐ Wall

Barrel deterioration and infiltration.

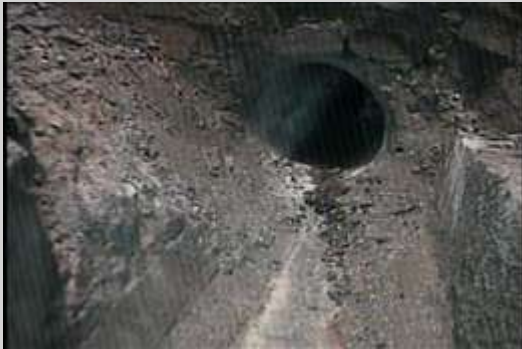
8 in. Circular Gravity Sewer Pipe Out @ 12 O'Clock

Bench and Channel deterioration.

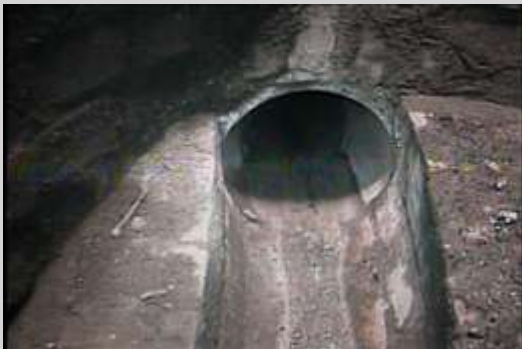
8 in. Circular Gravity Sewer Pipe In @ 5 O'Clock

Infiltration: **Evidence** Pipe Seal Cond: **Unknown**
